Submission on Contact Energy Limited's Lake Hāwea Draft Erosion Management Plan

28 July 2021

Guardians of Lake Hāwea

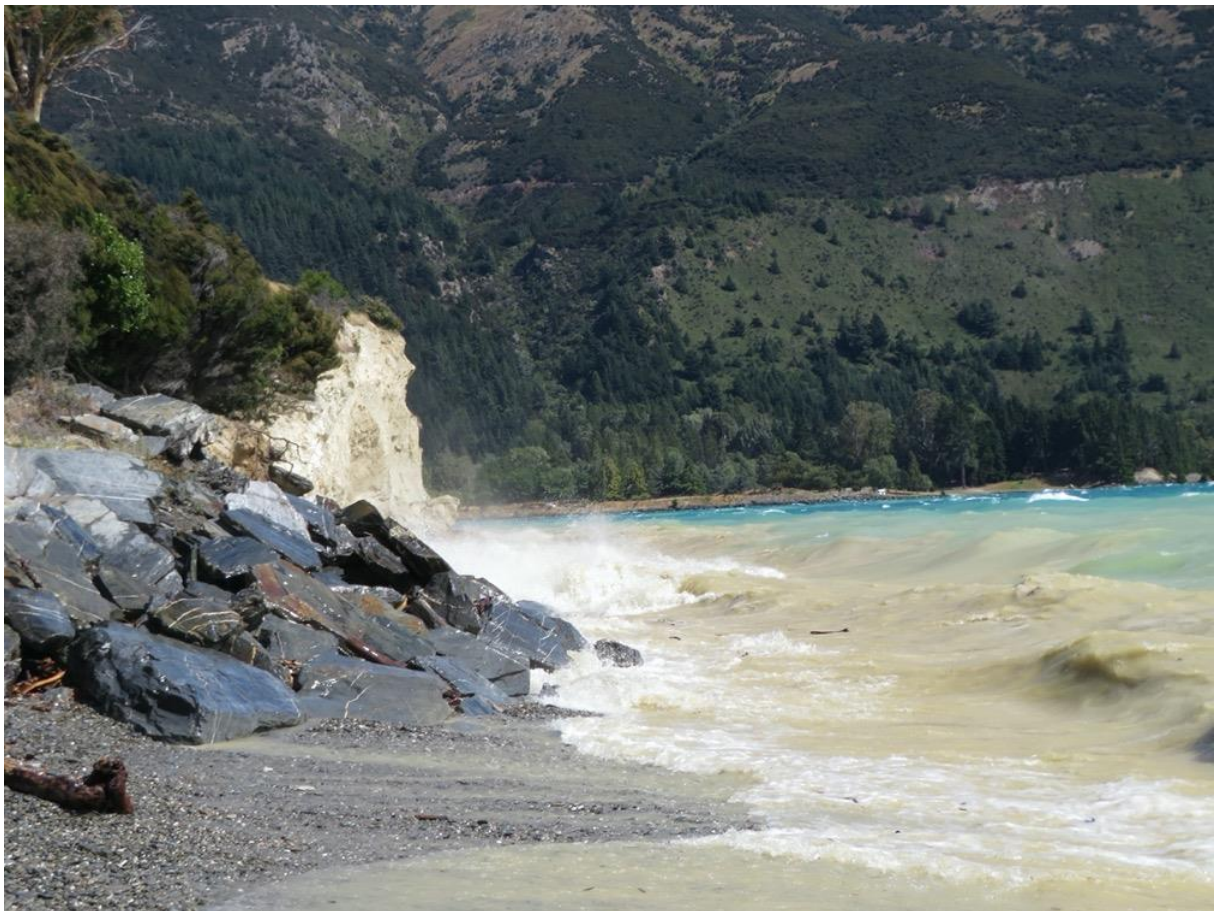
for this area was undertaken in 2018 (Silvester 2018) and it reports “slight average degradation”. We note there was significant cliff collapse in February 2020 which was associated with a high lake level and high winds (see Fig 1). This underscores the need for regular monitoring with additional surveys following significant events. Climate change is likely to result in more extreme weather events.

Fig 1. Eastern end of Flora Dora Cliffs 27 Feb 2020. The Wedding Tree (see below) can be seen in the top left of the frame

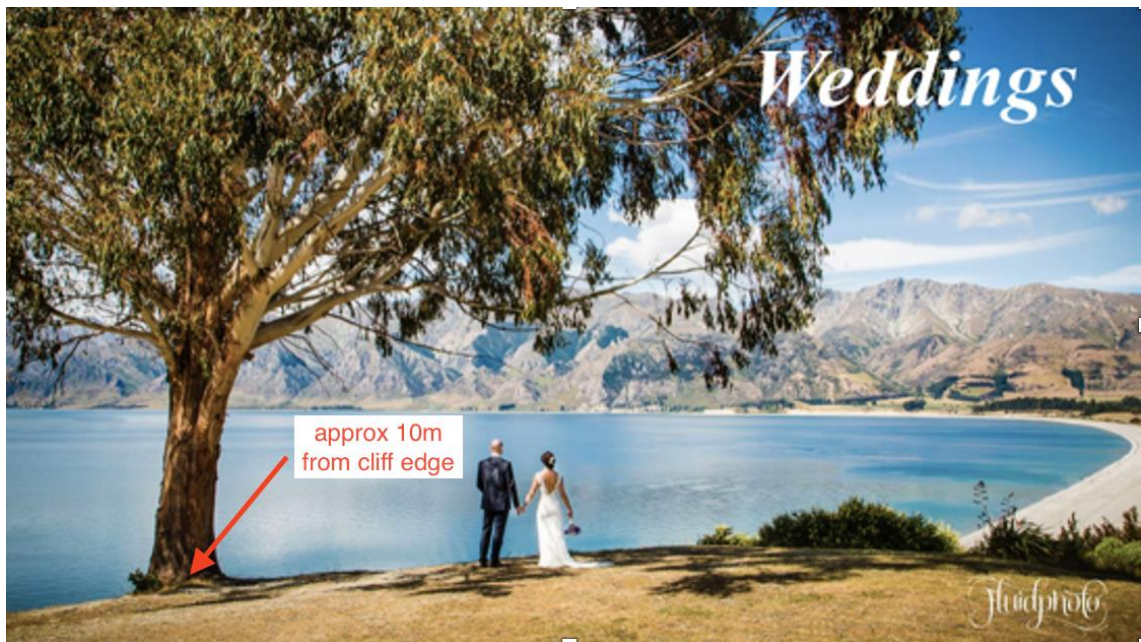
In addition, the eastern area of the Flora Dora reserve has a large Gum tree which is a very popular area for social gatherings. Evidence of the popularity of this area is evident by Lake Hāwea Community Centre advertising (see: <https://lakeHāwea.communitycentre.co.nz>) (see Fig 2). This area has also been the subject of extensive revegetation (Fig 3) by a group of volunteers (Thursday Group) working in partnership with QLDC. In summary, the Hawea community considers this area to be an important community asset and, as such, it warrants protection to ensure that further erosion is avoided.

Fig 2. Screen shot taken from Hāwea Community Centre Website of the Wedding Tree site on Flora Dora Cliffs, cliff edge information added.

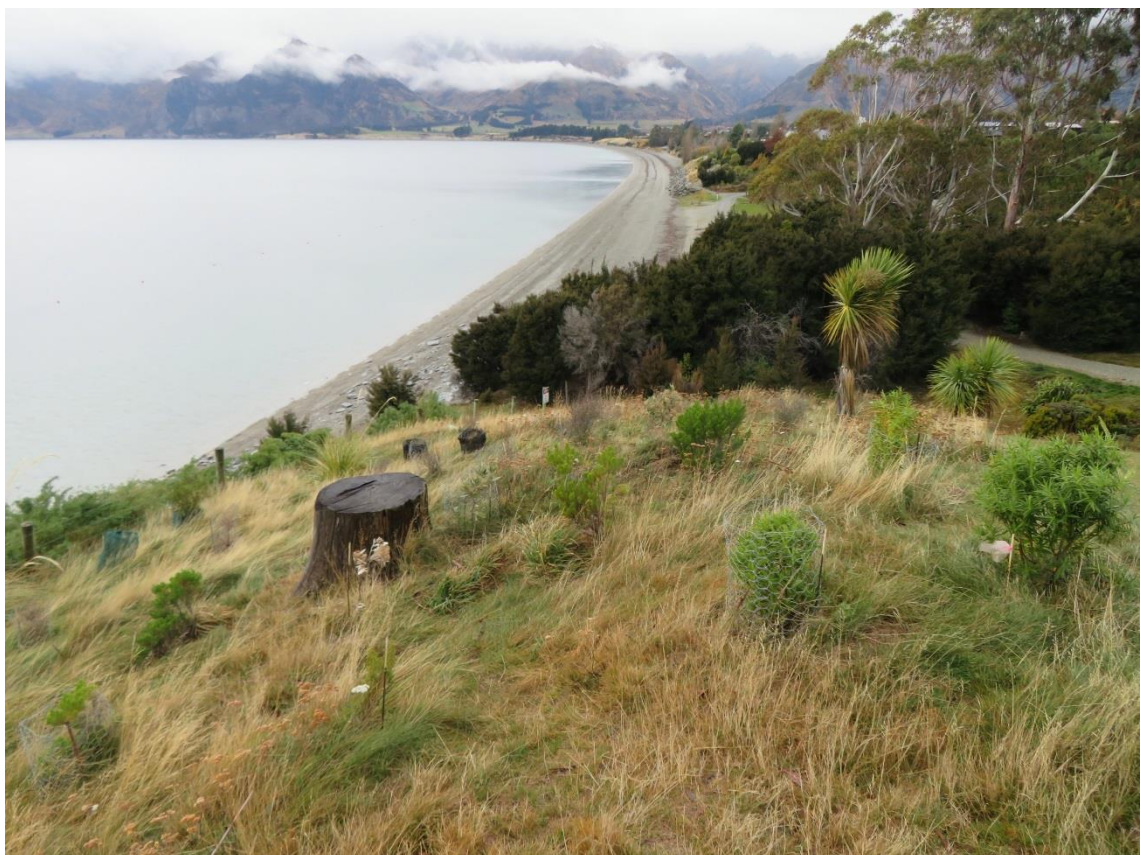
Fig 3. Revegetation on the east facing slope below the Wedding tree.

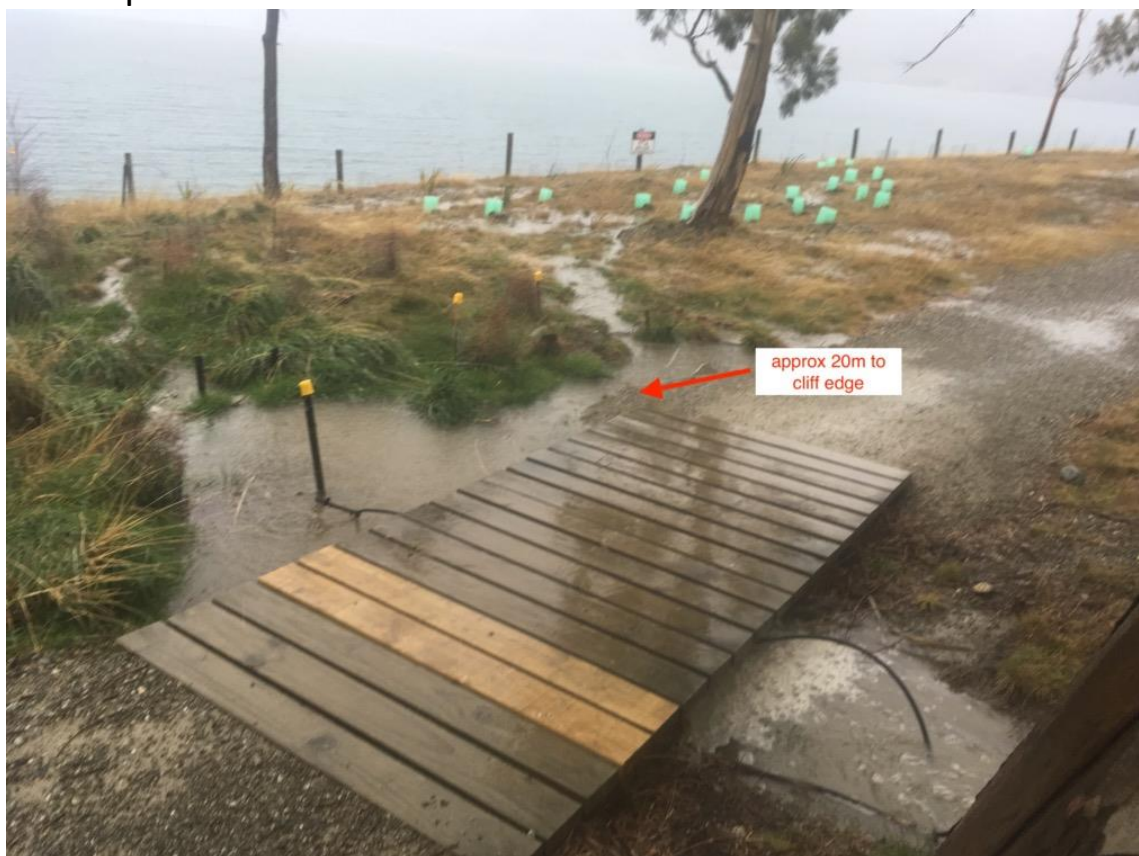
Finally, Contact Energy documents do not mention a significant contributor to the erosion of part of the cliff face, namely run-off from a QLDC stormwater drain. Figs 4 and 5 show this. GLH, and more latterly HCA’s three waters sub-committee, have been urging QLDC to address this issue. It

has been two years since GLH brought this to the attention of QLDC, when QLDC agreed it needed addressing. A number of mitigation options have been discussed with QLDC but this issue would appear to be a low priority for QLDC as there is no resolution in sight. Between June 2019 and May 2020 the cliff edge has retreated 1 metre at a point directly north of the stormwater outlet. The HCA Three Waters subcommittee is continuing to actively pursue a resolution of this problem.

Figure 4. flooding on Flora Dora terrace arising from open storm water drain. The boardwalk is on the Gladstone track

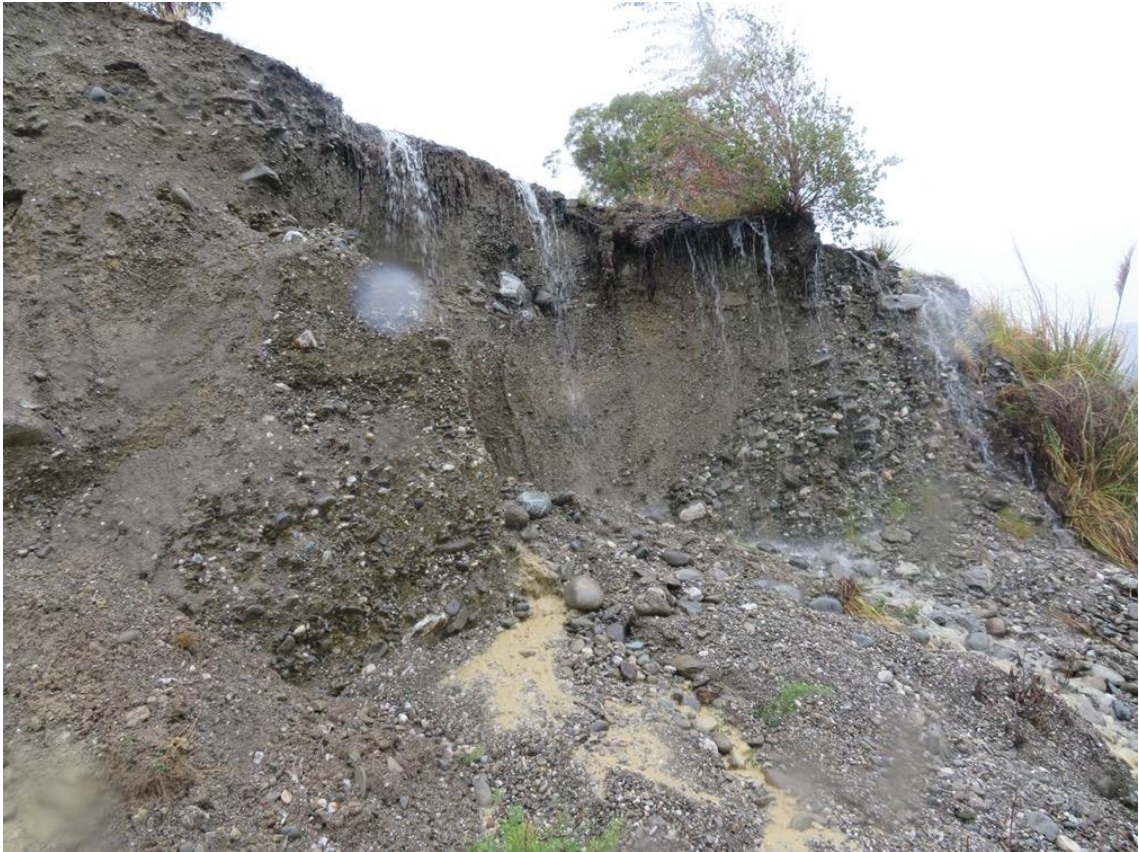
Fig 5. Flora Dora Cliffs directly north from stormwater drain

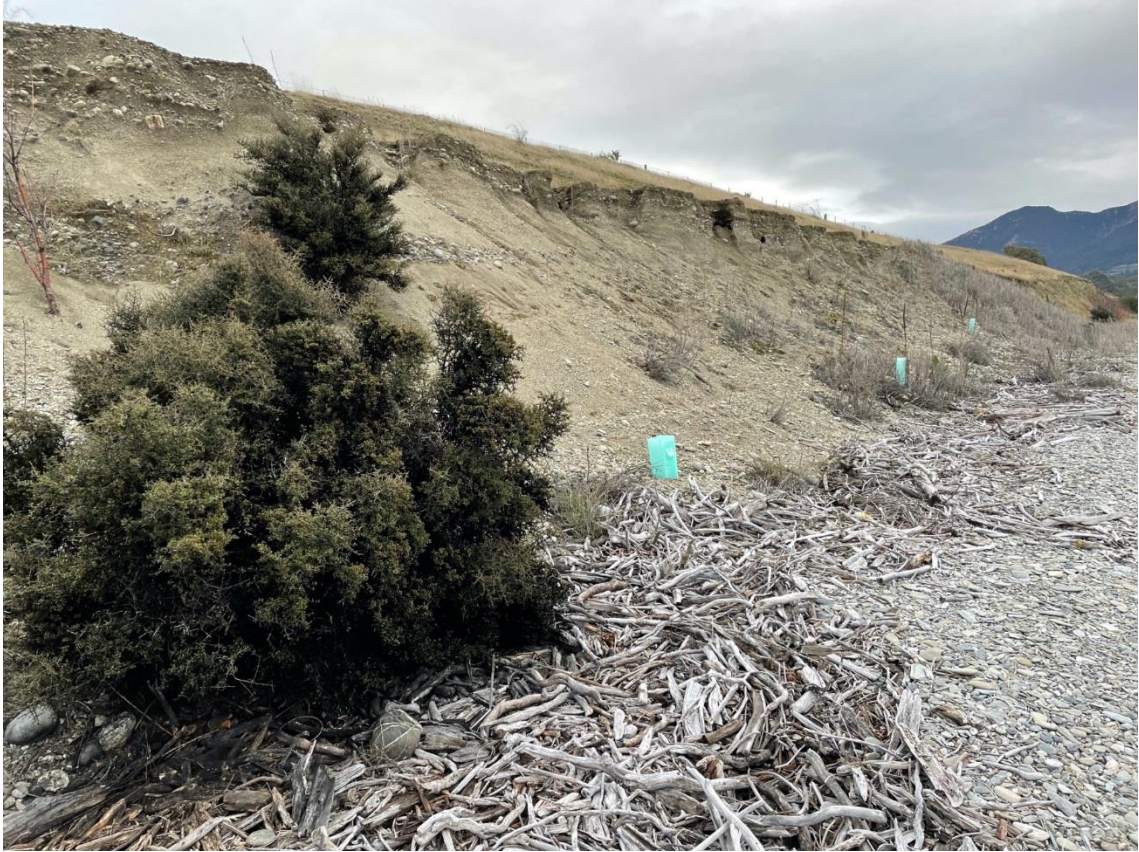
GLH are in agreement that no significant erosion appears to have occurred during the 2020 event when the lake level, at its height, allowed run-up to the base of the cliff. Natural ravelling (downslope movement of material) is occurring along the cliff due to gravity as the weak material attempts to reach its angle of repose, assisted by rabbit burrowing.

Figure 6 shows wood debris associated with the high lake level of early 2020.

Fig 6. Muir Road cliffs looking west June 2021

ribbonwood, and pittosporum species) in the lower gravel parts of the slope. This would considerably enhance the indigenous biodiversity of the area and provide a plant linkage corridor between the township foreshore vegetation and that at Gladstone Gap. Battering would not be necessary to undertake this task. Watering in the establishment phase could easily be undertaken by a pipeline from Contacts existing tank in the paddock above the cliffs.
