Wastewater Treatment and Land Treatment in Highly Variable Holiday Locations – Case Studies of two Queenstown Lakes Projects

Rob Potts^{a,d}, Brent Hawthorn^b, Melanie Heather^c

GLENDHU BAY

LAKE HAWEA

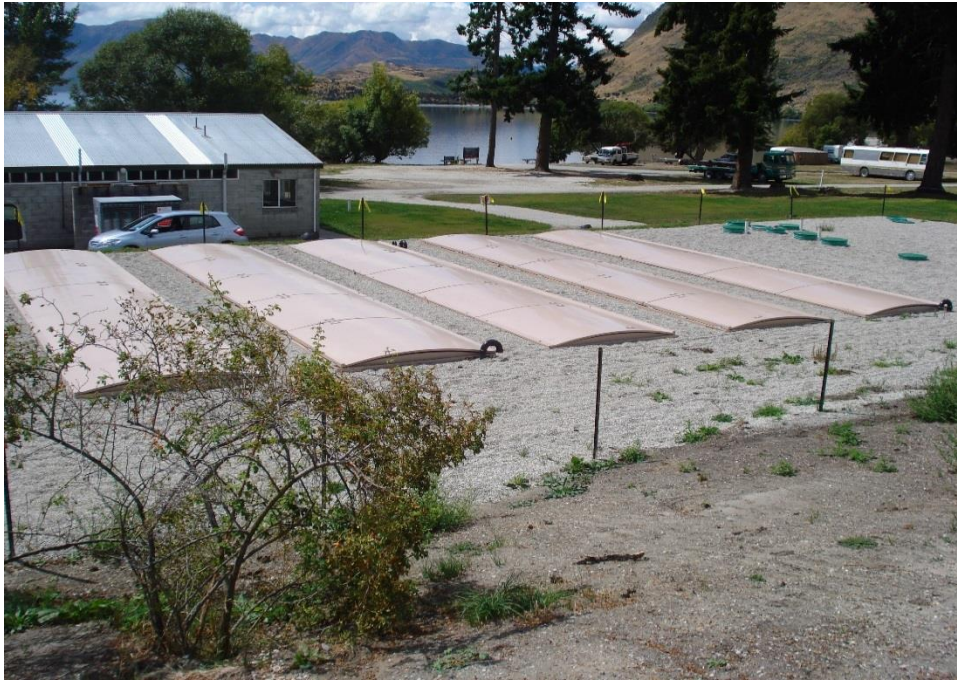
Figure 1: Photo showing Completed System

Innoflow replaced all but one of the existing septic tanks with new Septic Tank Effluent Pump (STEP) tanks and a small diameter effluent sewer reticulation network. Primary effluent, largely free of suspended solids and reduced BOD₅, was pumped to a pre-anoxic zone followed by pre-aeration before aerobic treatment through a bank of four AdvanTex–MAX™ recirculating textile packed bed filters (as seen in Figure 1). A post-anoxic zone was installed to meet the TN limits and a fifth AdvanTex–MAX™ is used for polishing prior to ultraviolet light disinfection and irrigation. The land application system comprises 24 discharge control trenches, each 93 m long. Distribution pipes are buried at the depth of 350 mm to avoid damage as the entire area contains tent and caravan camp sites.

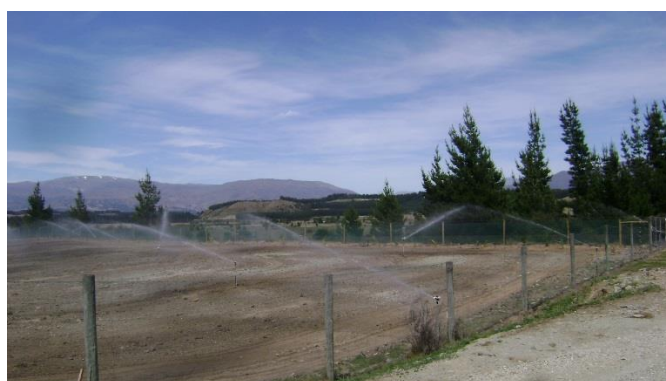
Figure 3a: Sprinkler System

The upgraded system utilises an upgraded disposal trench, with the overflow removed and a 2.33 ha land treatment area (LTA) using fixed sprinklers, as shown in Figure's 3a and 3b.

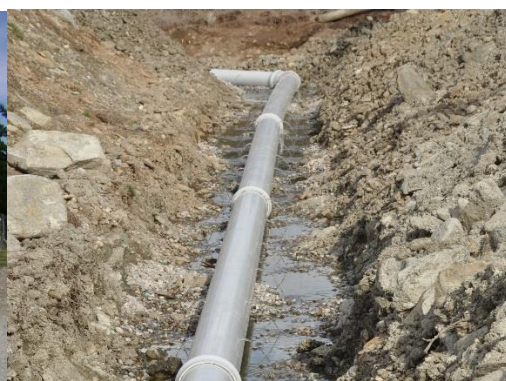
Figure 3b: Trench System
